Hydro-Services Ltd
P O Box 3132, CHRISTCHURCH

CLAW Micro-Farm Block 1/2 - Onions

Tuesday 3 Nov 2015

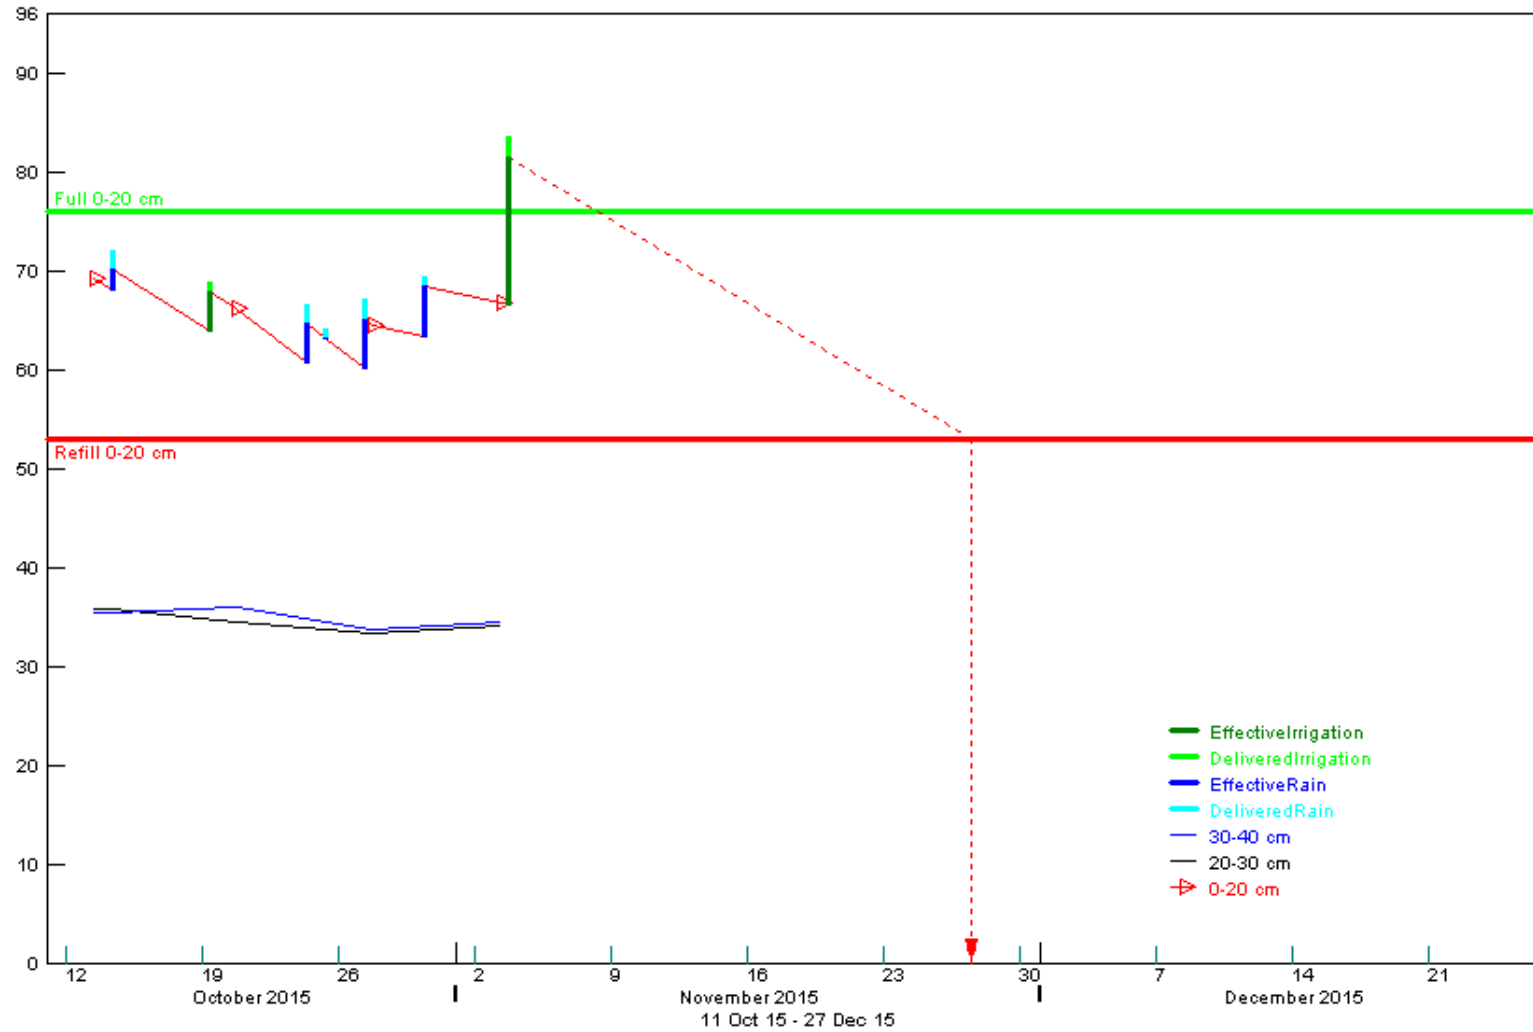
RootZone	Full	REFILL	Previous	Current	Deficit	Probe Dwu	Pdwu Date	EDWU	Date	Amount
0-20 cm	76 mm	53 mm	65 mm	82 mm	-6 mm	0.4 mm/day	8 Jan	1.2 mm/day	27 11 11:37	23 mm

SITE NAME	RAINFALL (mm)	IRRIGATION (mm)	DAILY WATER USE (mm/day)	RECOMMENDATIONS
Microfarm Block 1/2 Onions	6	17 today	1.2	No irrigation required
Microfarm Block 5 Peas	6	0	1.6	11/11 20mm
Microfarm Block 3 Peas	14	0	1.4	14/11 20mm
Microfarm Block 4 Peas	14	0	1.6	11/11 20mm

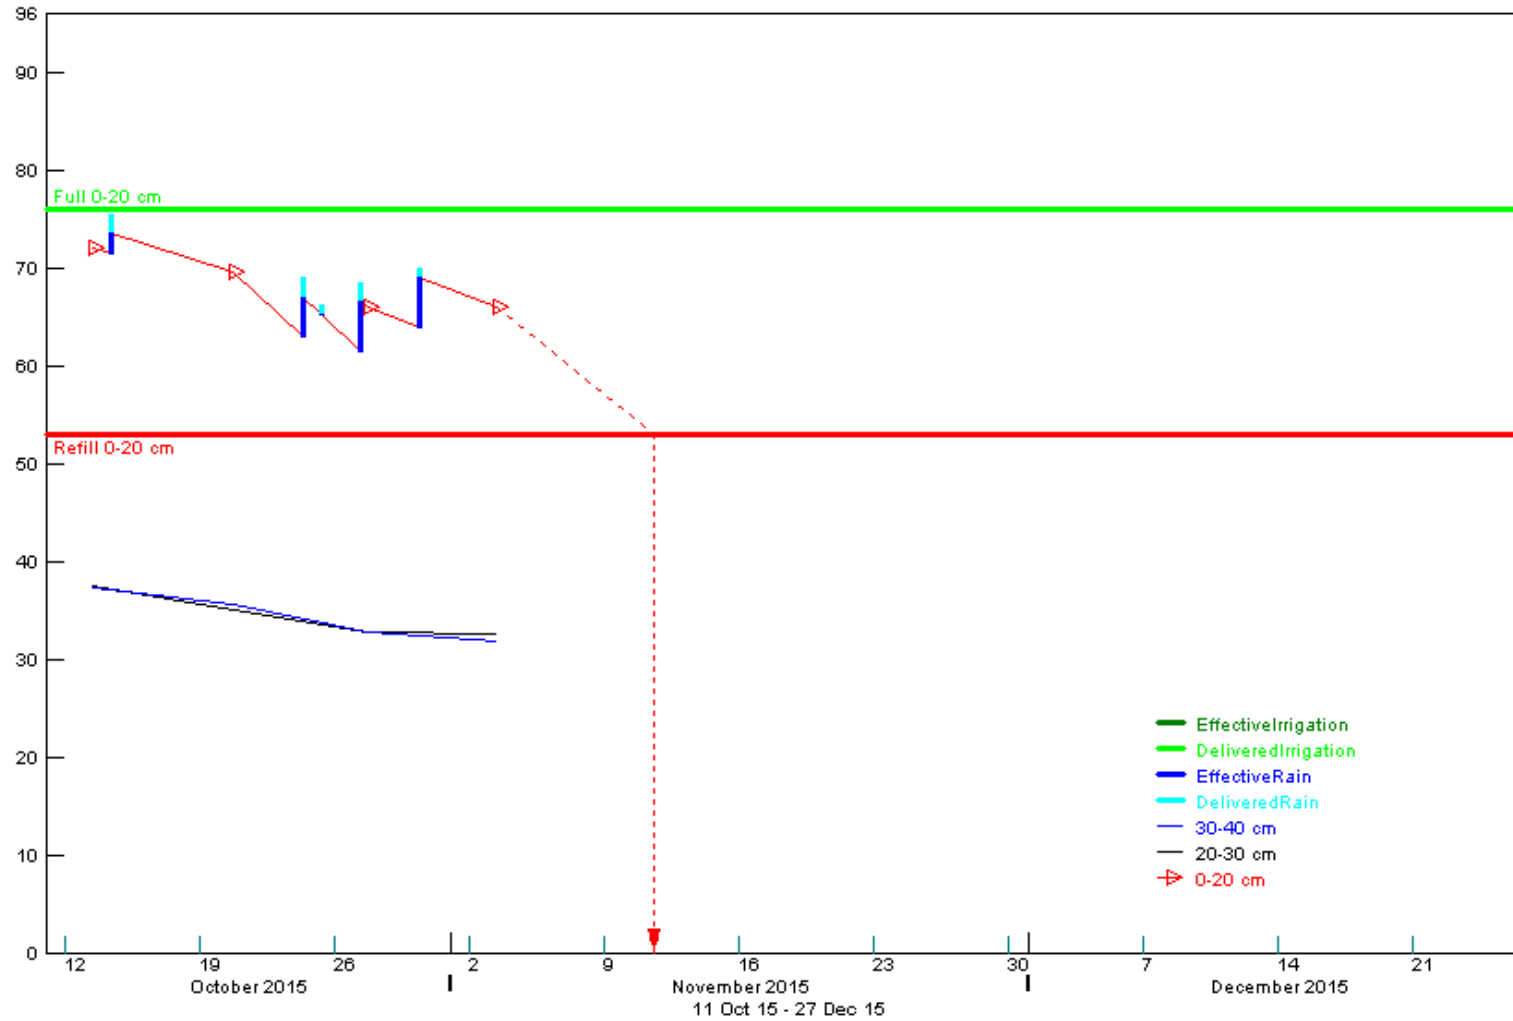
CLAW Micro-Farm Block 5 - Peas

RootZone	Full	REFILL	Previous	Current	Deficit	Probe Dwu	Pdww Date	EDWU	Date	Amount
0-20 cm	76 mm	53 mm	66 mm	66 mm	10 mm	0.7 mm/day	21 Nov	1.6 mm/day	11 11 12:45	23 mm

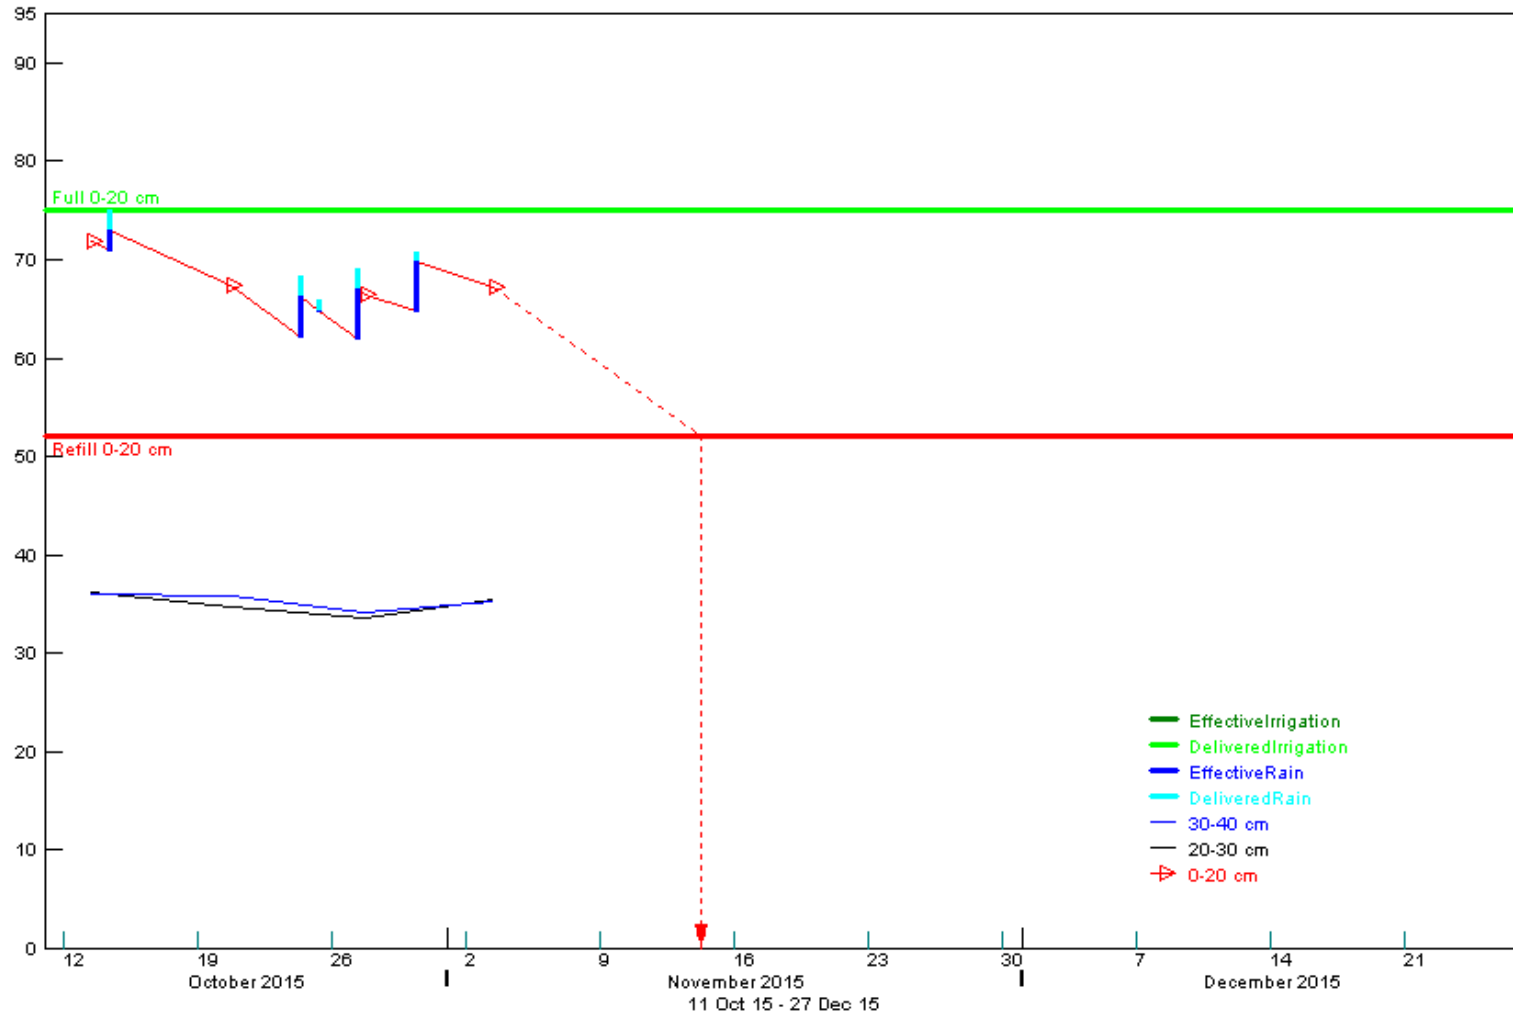
CLAW Micro-Farm Blk 3 - Peas

RootZone	Full	REFILL	Previous	Current	Deficit	Probe Dwu	Pdww Date	EDWU	Date	Amount
0-20 cm	75 mm	52 mm	67 mm	67 mm	8 mm	0.6 mm/day	27 Nov	1.4 mm/day	14 11 5:48	23 mm

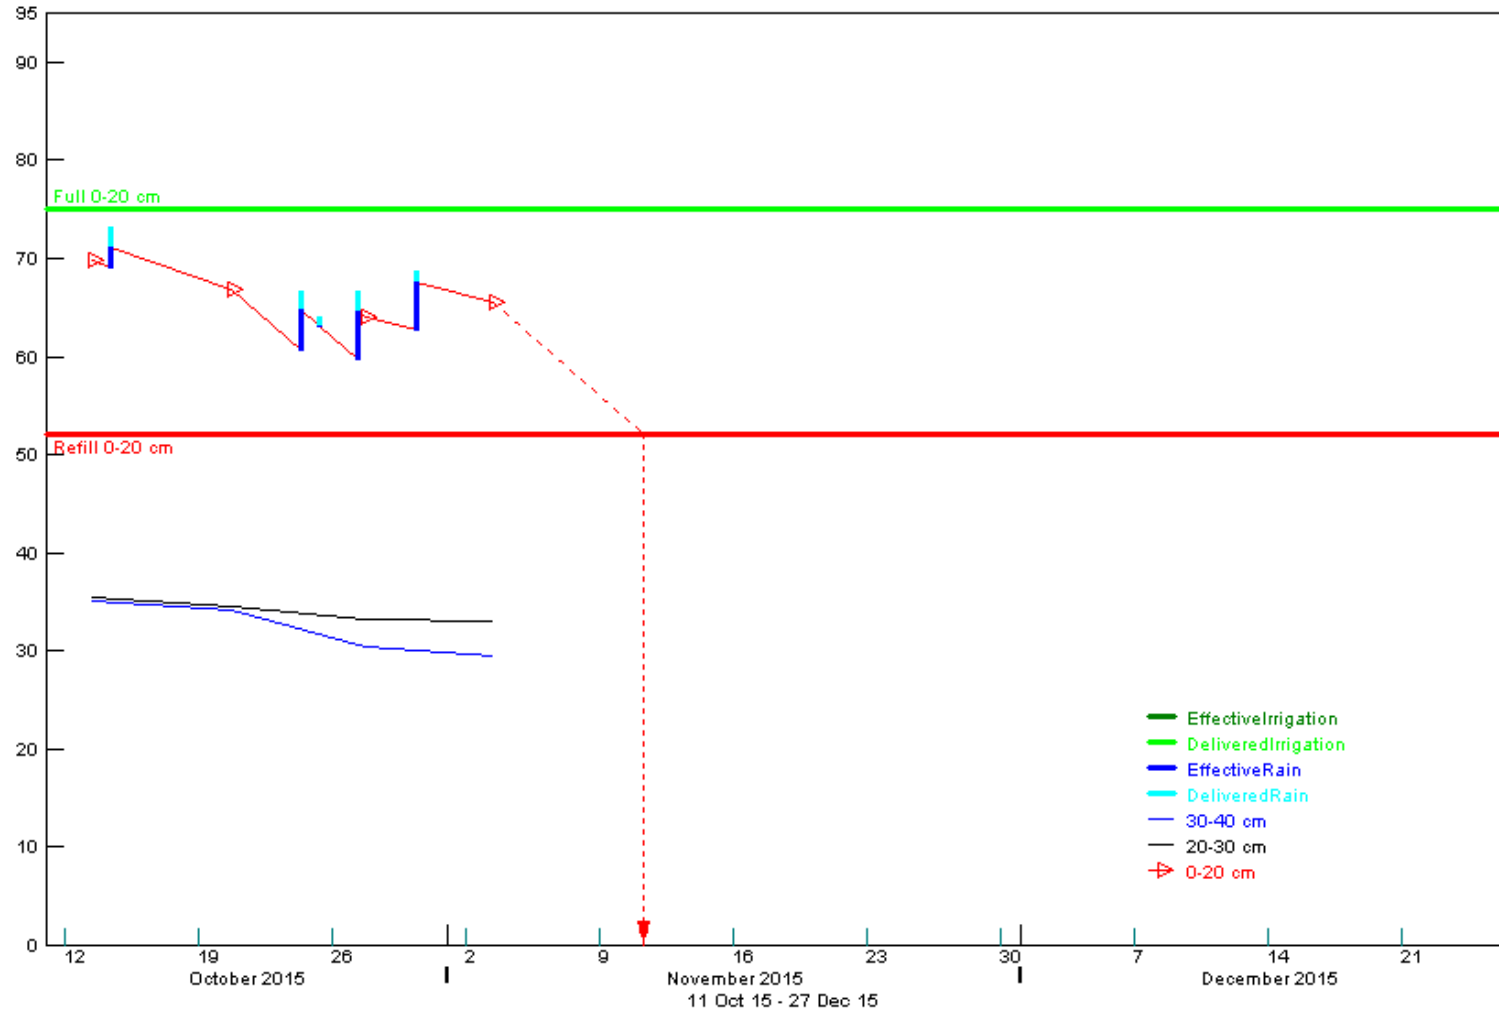
CLAW Micro-Farm Blk 4 - Peas

RootZone	Full	REFILL	Previous	Current	Deficit	Probe Dmw	Pdmw Date	EDWU	Date	Amount
0-20 cm	75 mm	52 mm	64 mm	65 mm	10 mm	0.5 mm/day	27 Nov	1.7 mm/day	11 11 6:26	23 mm
