Hydro-Services Ltd
P O Box 3132, CHRISTCHURCH

CLAW Micro-Farm Block 1/2 - Onions

Monday 23 Nov 2015

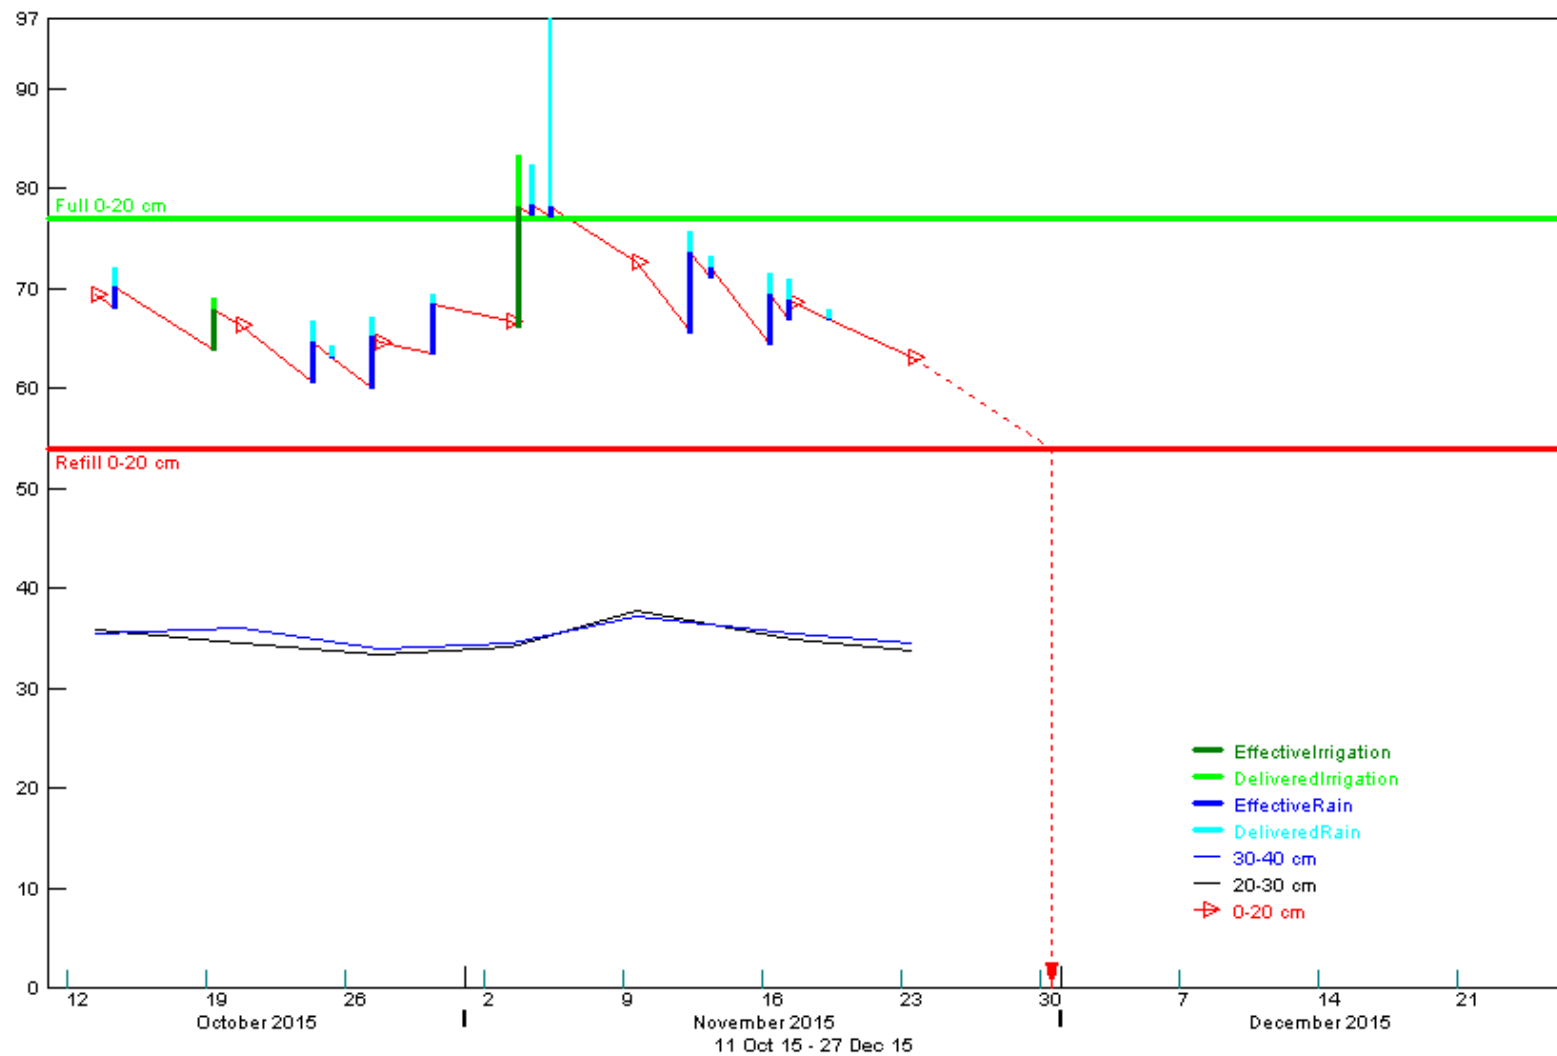
RootZone	Full	REFILL	Previous	Current	Deficit	Probe Dwu	Pdww Date	EDWU	Date	Amount
0-20 cm	77 mm	54 mm	69 mm	63 mm	14 mm	0.9 mm/day	3 Dec	1.3 mm/day	30 11 12:49	23 mm

SITE NAME	RAINFALL (mm)	IRRIGATION (mm)	DAILY WATER USE (mm/day)	RECOMMENDATIONS
Microfarm Block 1/2 Onions	1	0	1.3	28/11 20mm
Microfarm Block 5 Peas	1	0	1.8	26/11 23mm
Microfarm Block 3 Peas	1	0	2.0	26/11 23mm
Microfarm Block 4 Peas	1	0	2.1	25/11 23mm

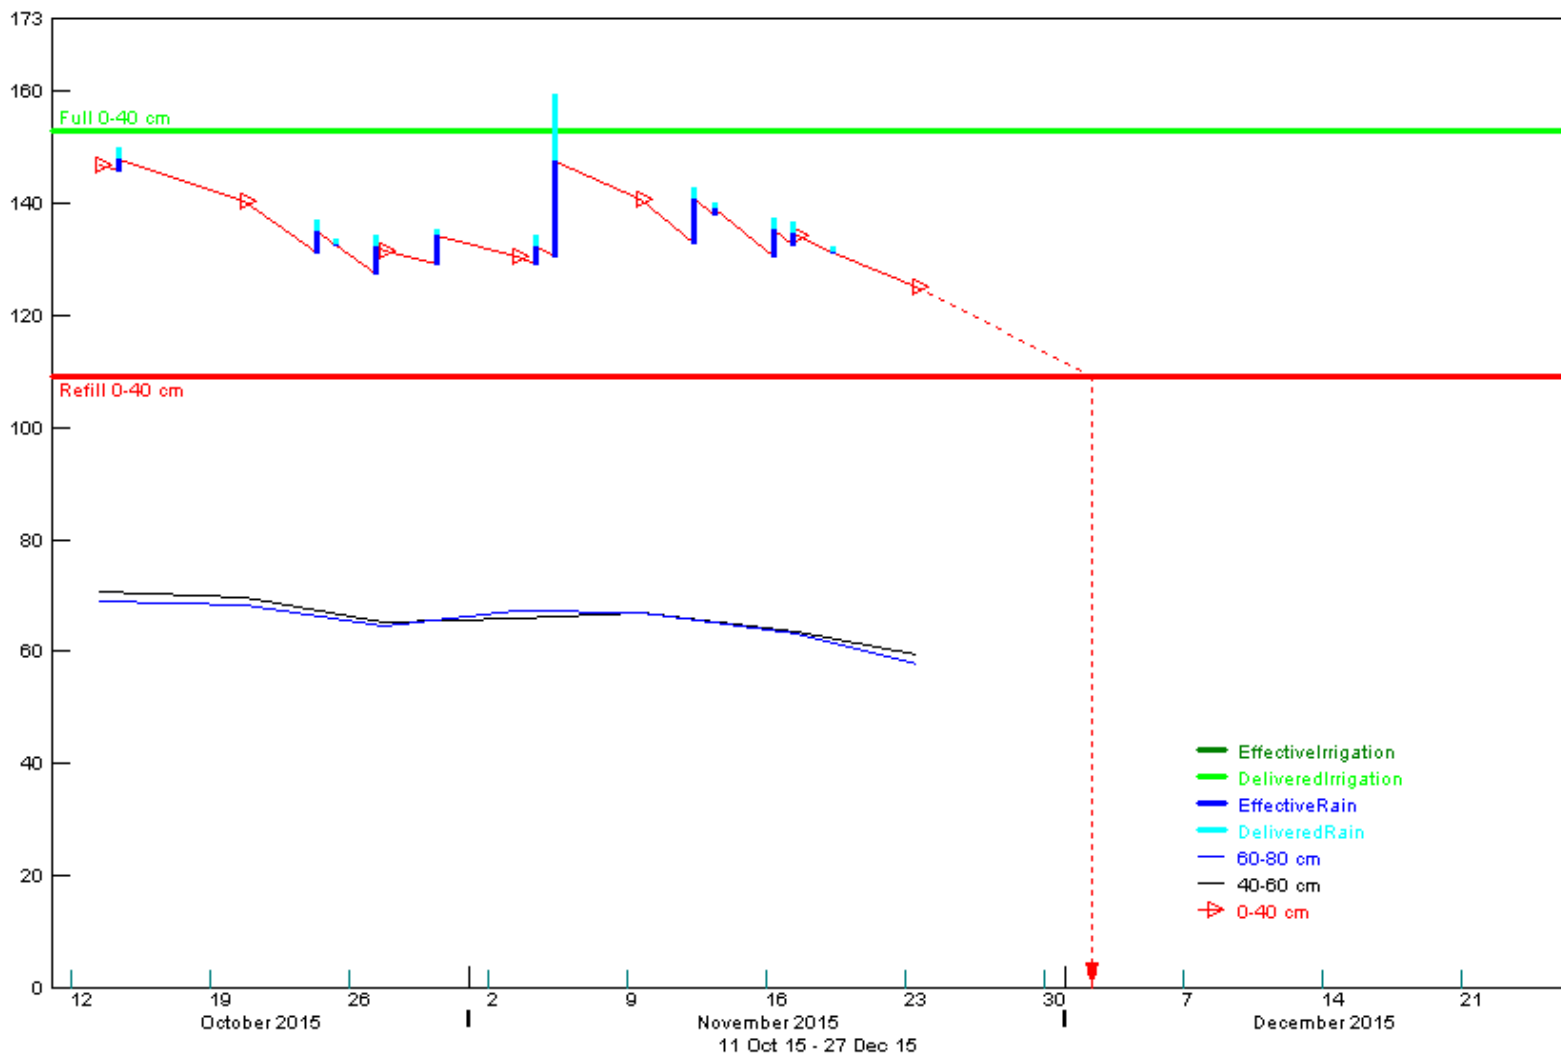
CLAW Micro-Farm Block 5 - Peas

RootZone	Full	REFILL	Previous	Current	Deficit	Probe Dwu	Pdww Date	EDWU	Date	Amount
0-40 cm	153 mm	109 mm	134 mm	125 mm	28 mm	1.5 mm/day	3 Dec	1.8 mm/day	2 12 8:44	44 mm

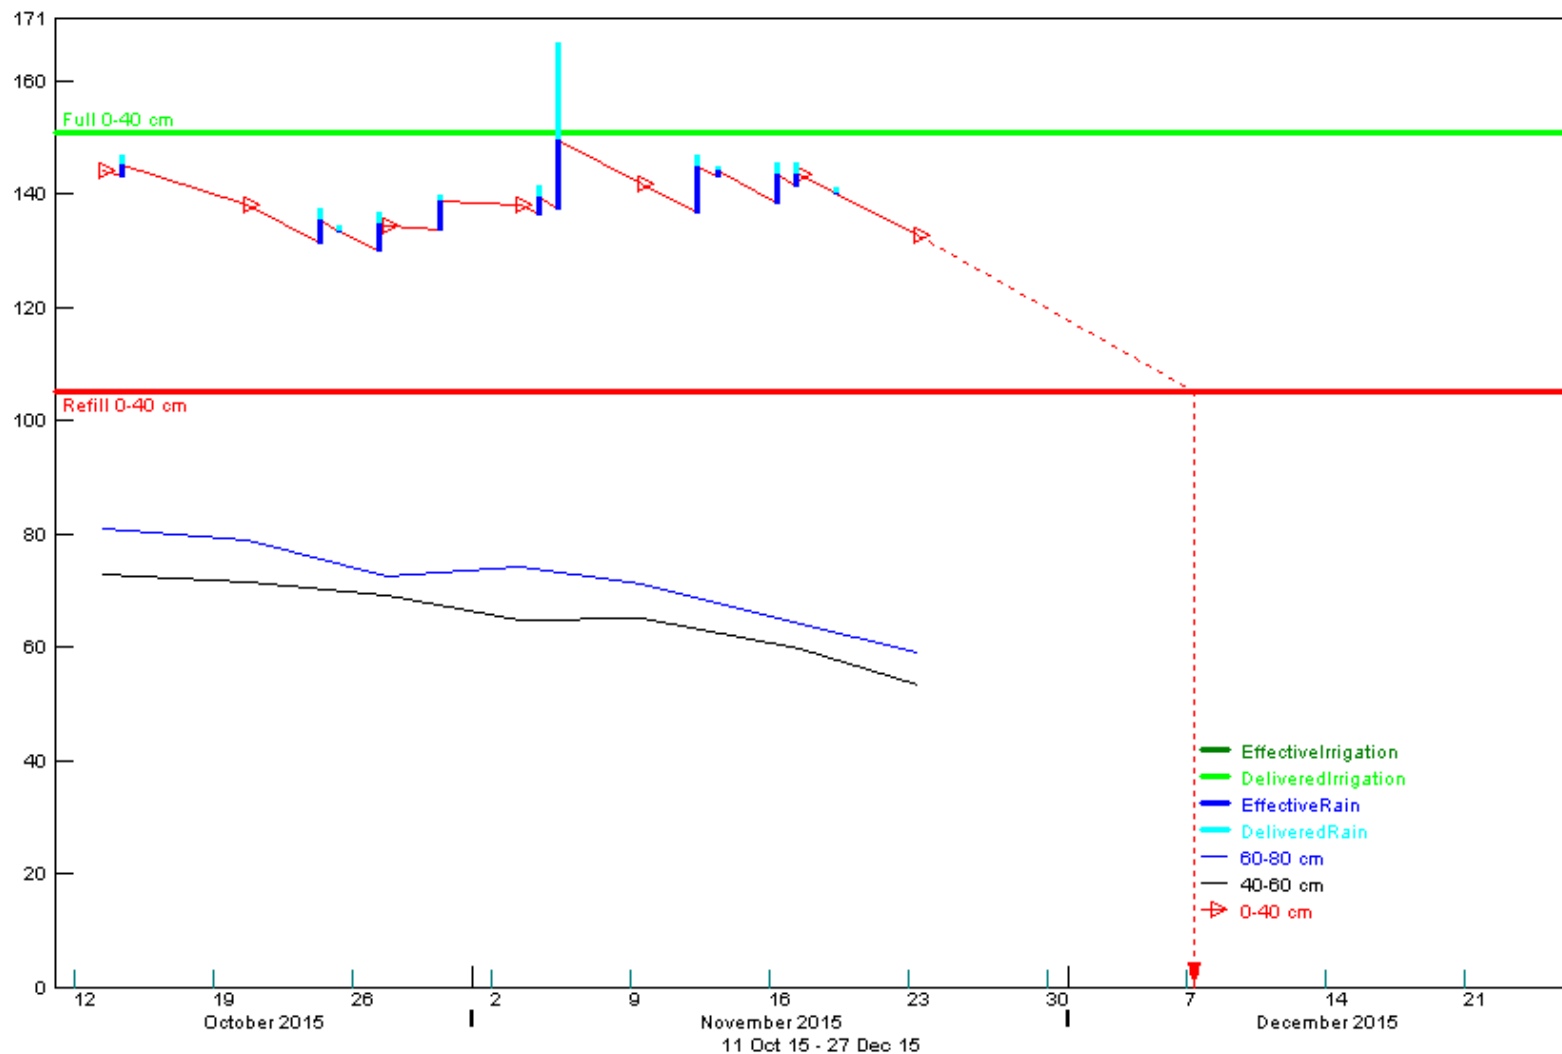
CLAW Micro-Farm Blk 3 - Peas

RootZone	Full	REFILL	Previous	Current	Deficit	Probe Dwu	Pdww Date	EDWU	Date	Amount
0-40 cm	151 mm	105 mm	143 mm	133 mm	18 mm	1.8 mm/day	9 Dec	2.0 mm/day	7 12 8:42	46 mm

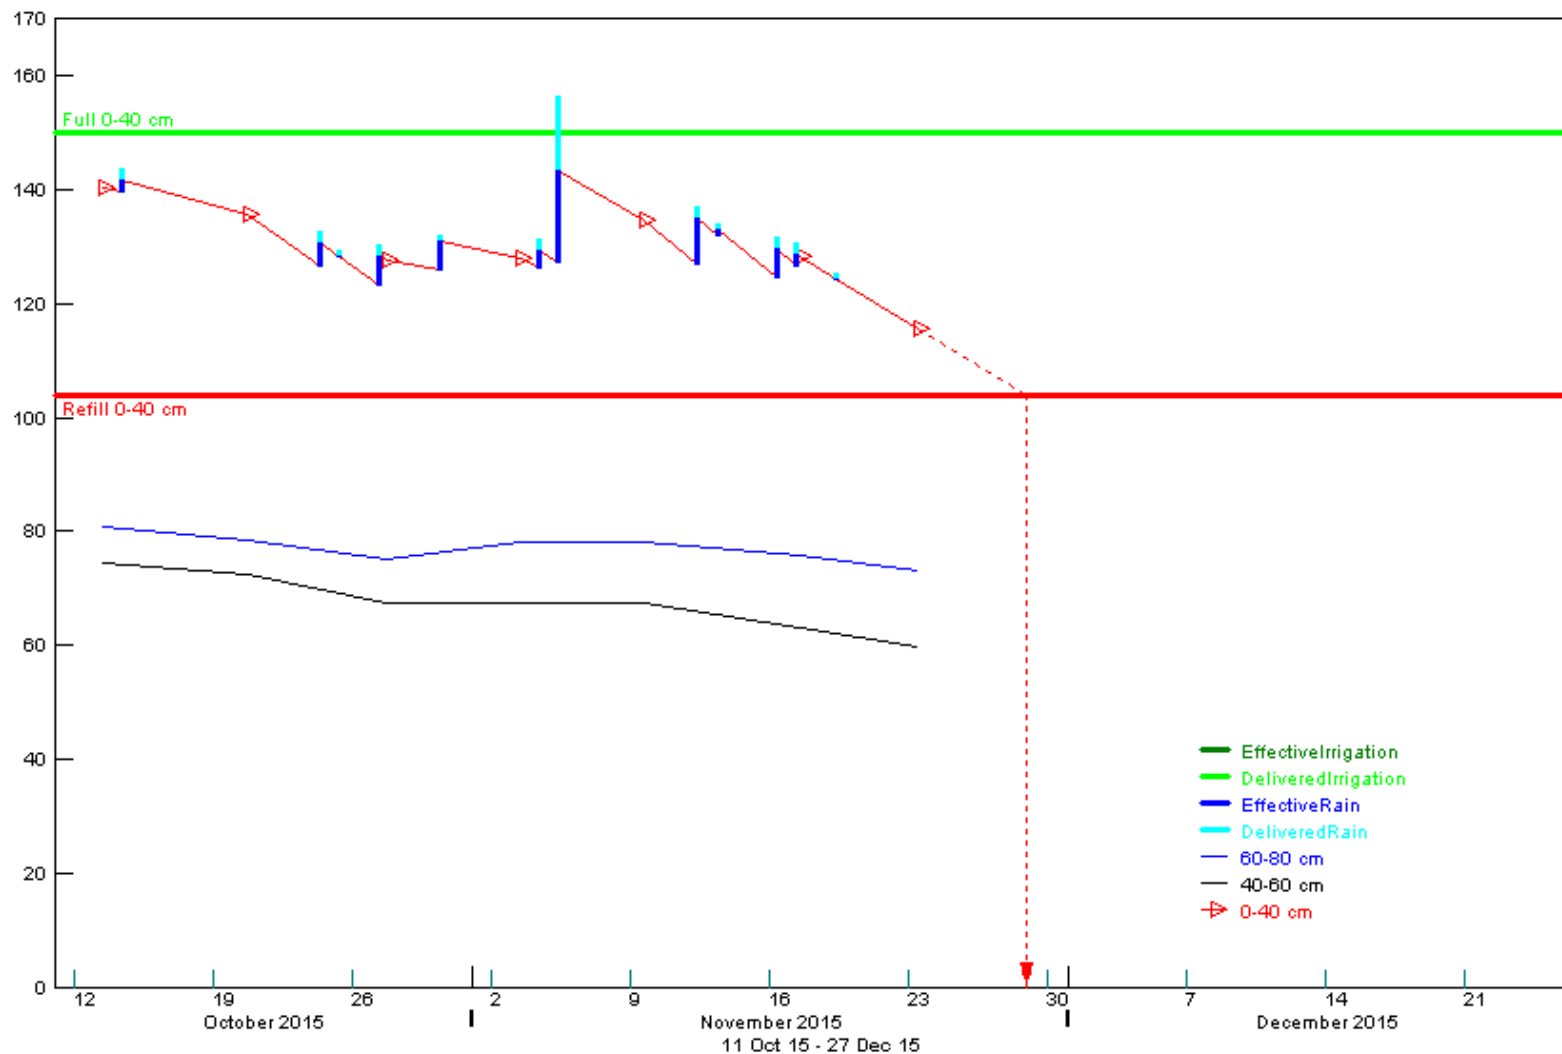
CLAW Micro-Farm Blk 4 - Peas

- EffectiveIrrigation
- DeliveredIrrigation
- EffectiveRain
- DeliveredRain
- 60-80 cm
- 40-80 cm
- 0-40 cm

RootZone	Full	REFILL	Previous	Current	Deficit	Probe Dwu	Pdww Date	EDWU	Date	Amount
0-40 cm	150 mm	104 mm	128 mm	115 mm	35 mm	2.1 mm/day	28 Nov	2.1 mm/day	28 11 22:49	46 mm
