Hydro-Services Ltd
P O Box 3132, CHRISTCHURCH

CLAW Micro-Farm Block 1/2 - Onions

Monday 14 Dec 2015

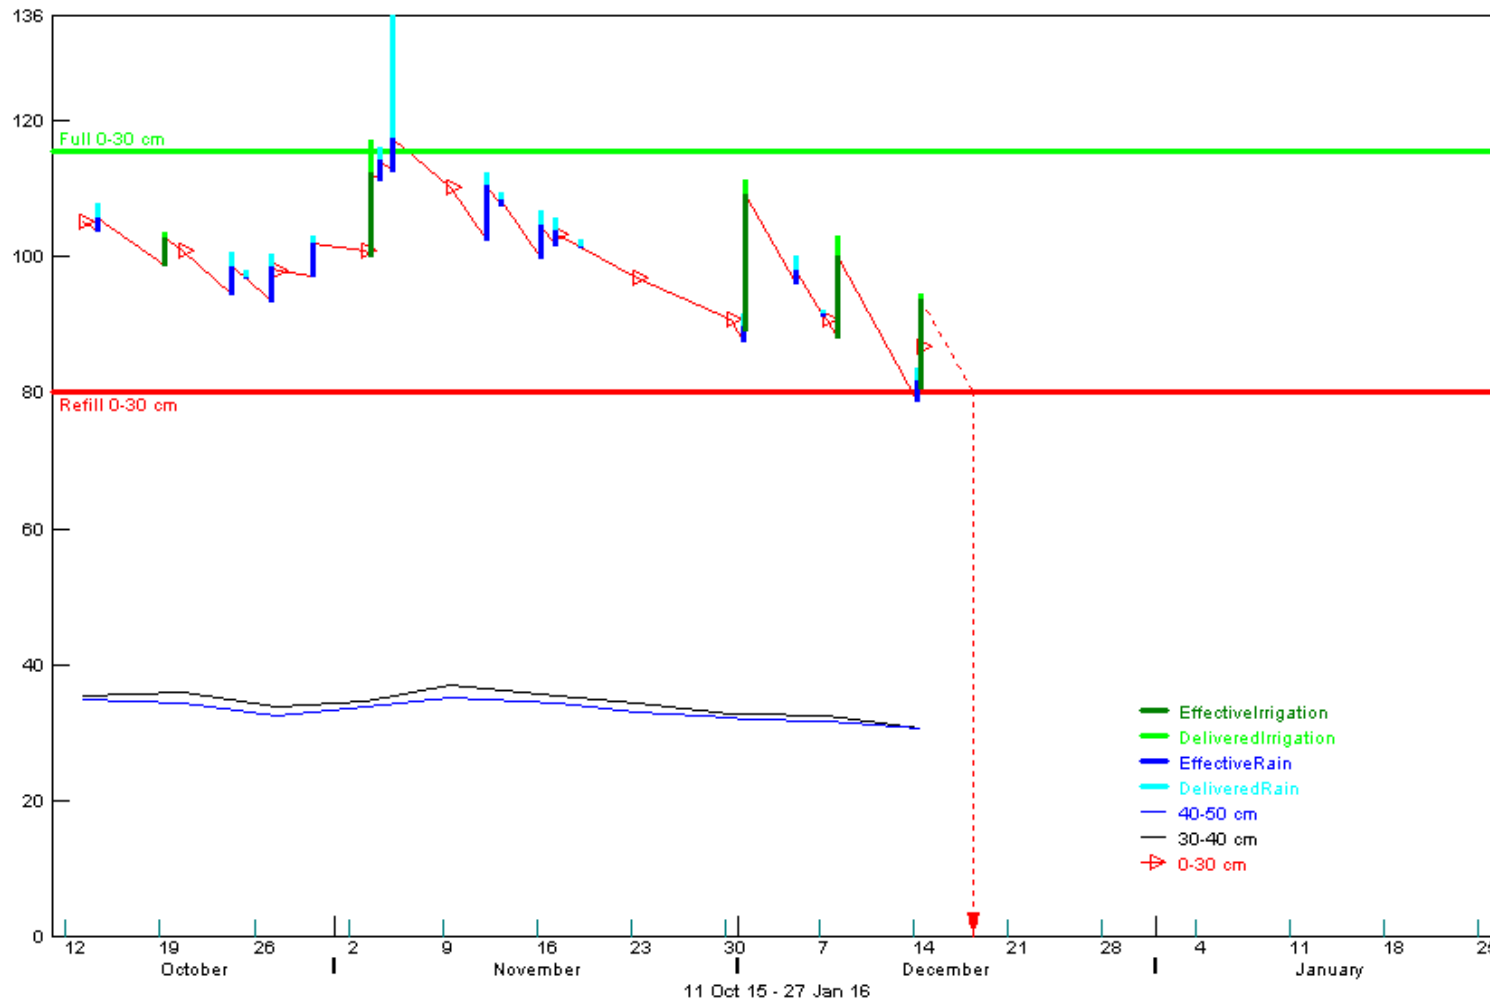
RootZone	Full	REFILL	Previous	Current	Deficit	Probe Dwu	Pdww Date	EDWU	Date	Amount
0-30 cm	116 mm	80 mm	91 mm	94 mm	22 mm	3.6 mm/day	18 Dec	3.6 mm/day	18 12 9:54	36 mm

SITE NAME	RAINFALL (mm)	IRRIGATION (mm)	DAILY WATER USE (mm/day)	RECOMMENDATIONS
Microfarm Block 1/2 Onions	5	30	3.6	16/12 15mm 18/12 15mm
Microfarm Block 5 Peas	5	15	3.6	SITE REMOVED
Microfarm Block 3 Peas	5	15	3.3	SITE REMOVED
Microfarm Block 4 Peas	5	15	2.0	SITE REMOVED

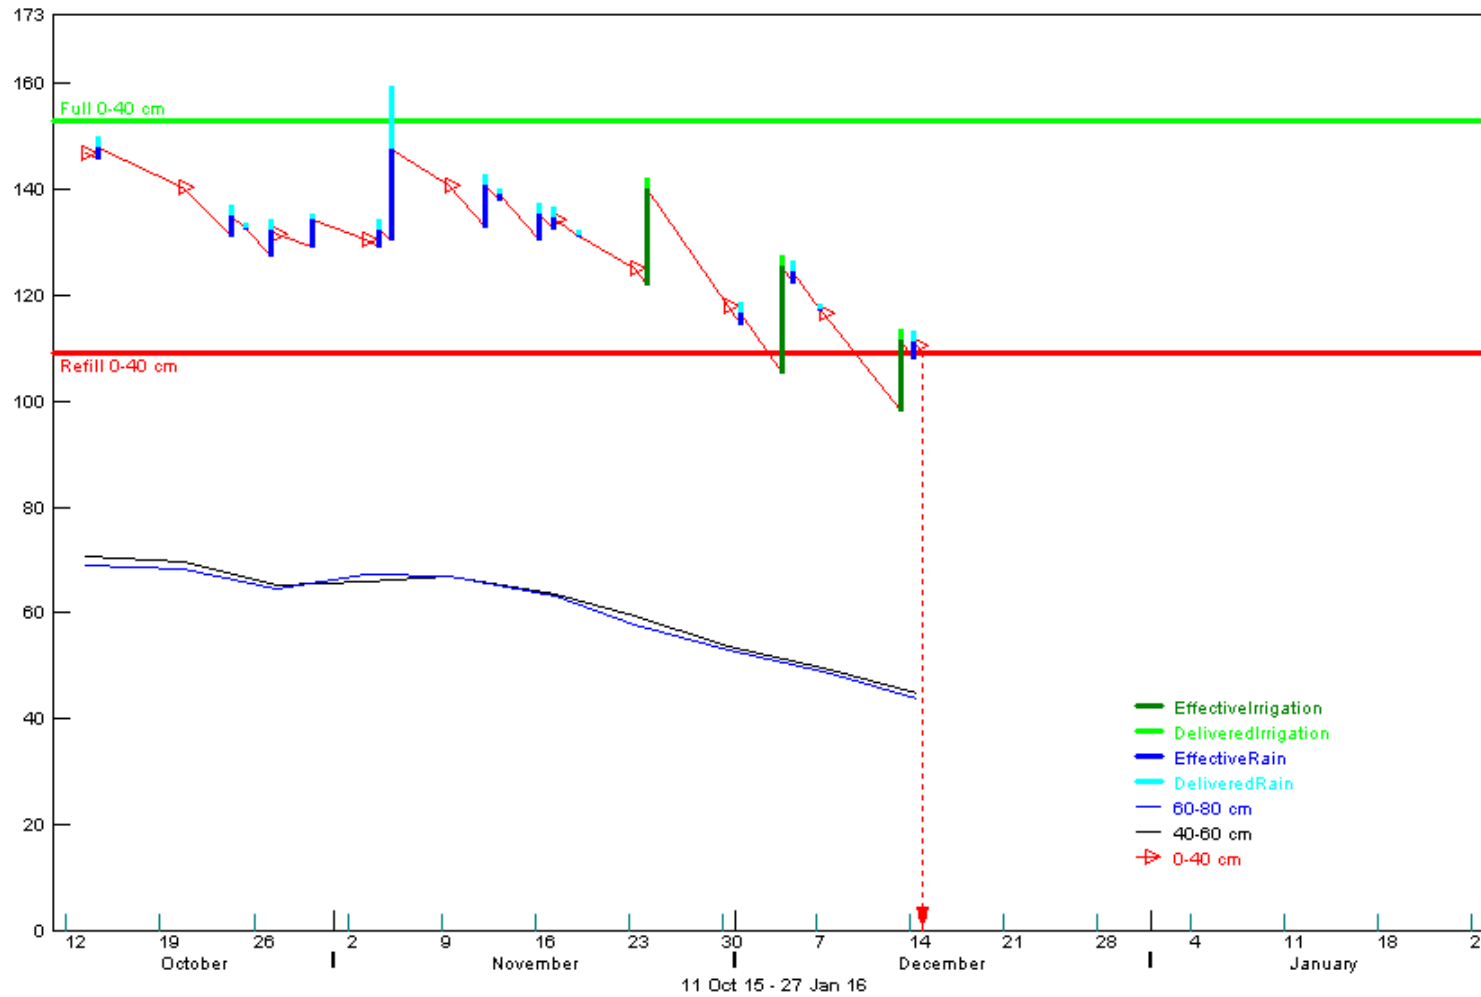
CLAW Micro-Farm Block 5 - Peas

RootZone	Full	REFILL	Previous	Current	Deficit	Probe Dwu	Pdww Date	EDWU	Date	Amount
0-40 cm	153 mm	109 mm	116 mm	110 mm	43 mm	3.1 mm/day	15 Dec	3.6 mm/day	14 12 23:45	44 mm

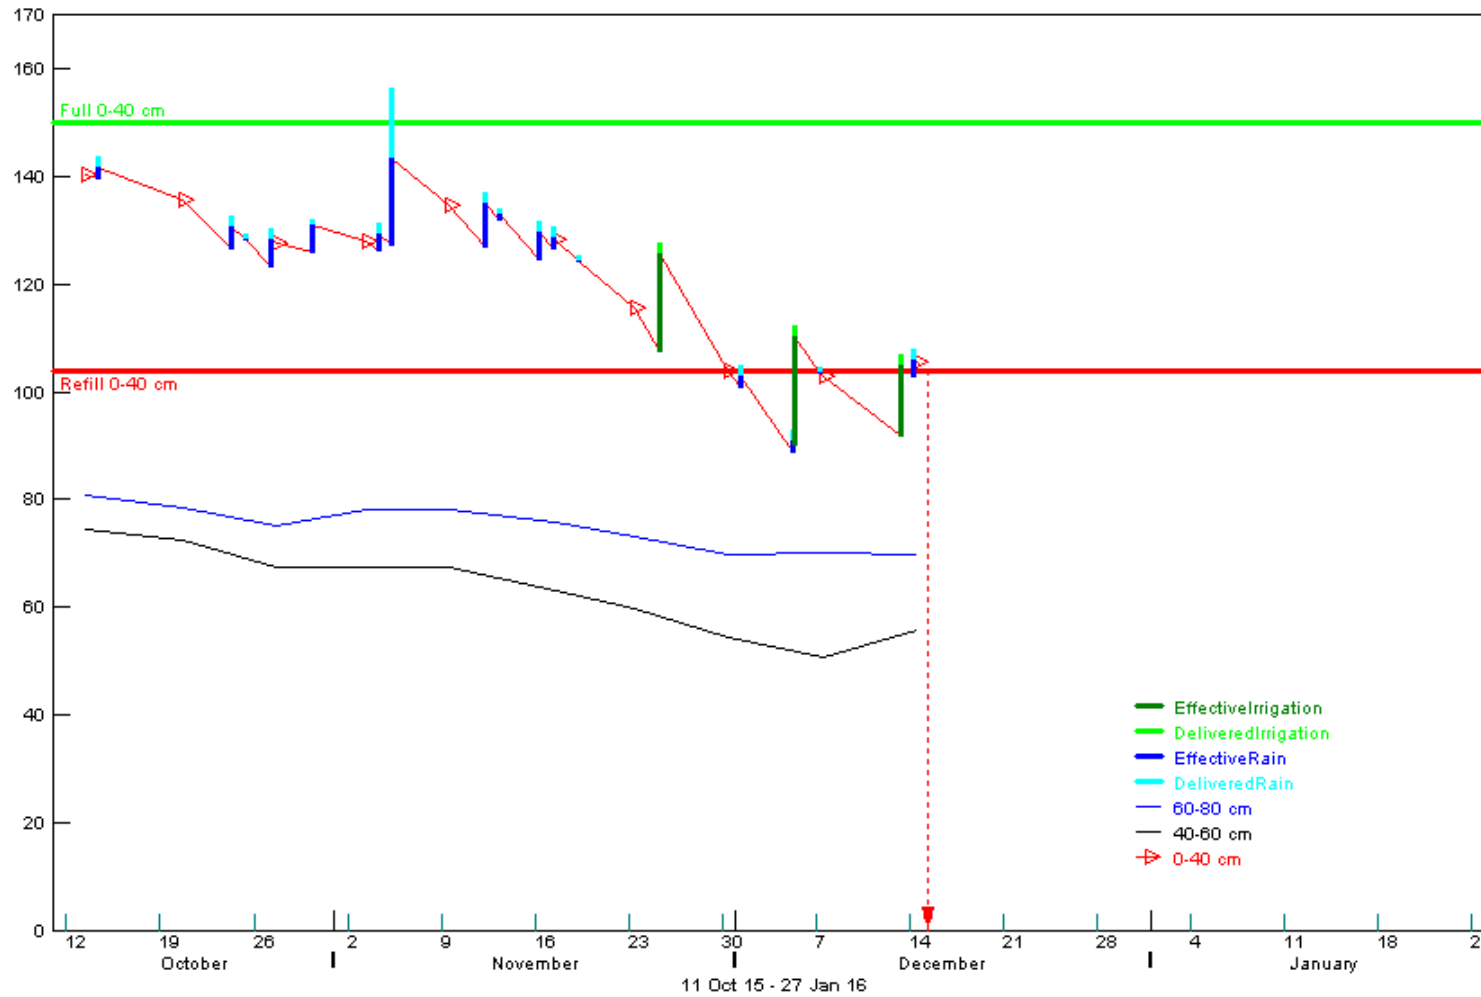
CLAW Micro-Farm Blk 4 - Peas

RootZone	Full	REFILL	Previous	Current	Deficit	Probe Dwu	Pdww Date	EDWU	Date	Amount
0-40 cm	150 mm	104 mm	103 mm	105 mm	45 mm	1.9 mm/day	15 Dec	2.0 mm/day	15 12 7:38	46 mm

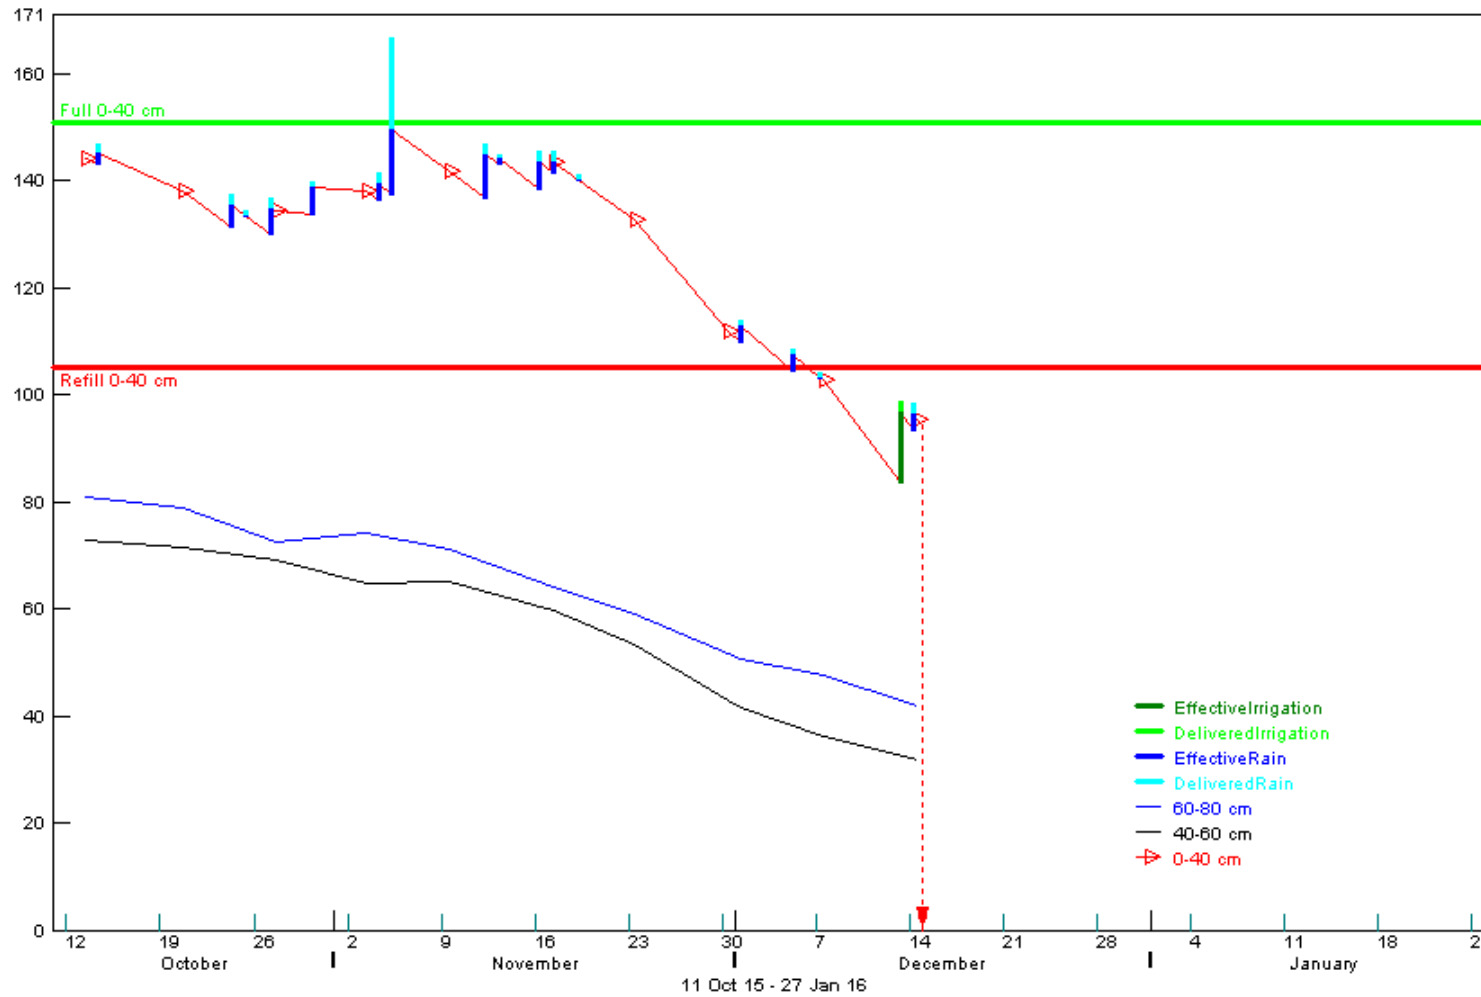
CLAW Micro-Farm Blk 3 - Peas

RootZone	Full	REFILL	Previous	Current	Deficit	Probe Dwu	Pdww Date	EDWU	Date	Amount
0-40 cm	151 mm	105 mm	103 mm	96 mm	55 mm	3.3 mm/day	14 Dec	3.3 mm/day	14 12 22:37	46 mm
